Dhimish, Mahmoud and Lazaridis, Pavlos I. (2021) An empirical investigation on the correlation between solar cell cracks and hotspots. Scientific Reports. ISSN 2045-2322

# An empirical investigation on the correlation between solar cell cracks and hotspots

Mahmoud Dhimish<sup>1✉</sup> & Pavlos I. Lazaridis<sup>2</sup>

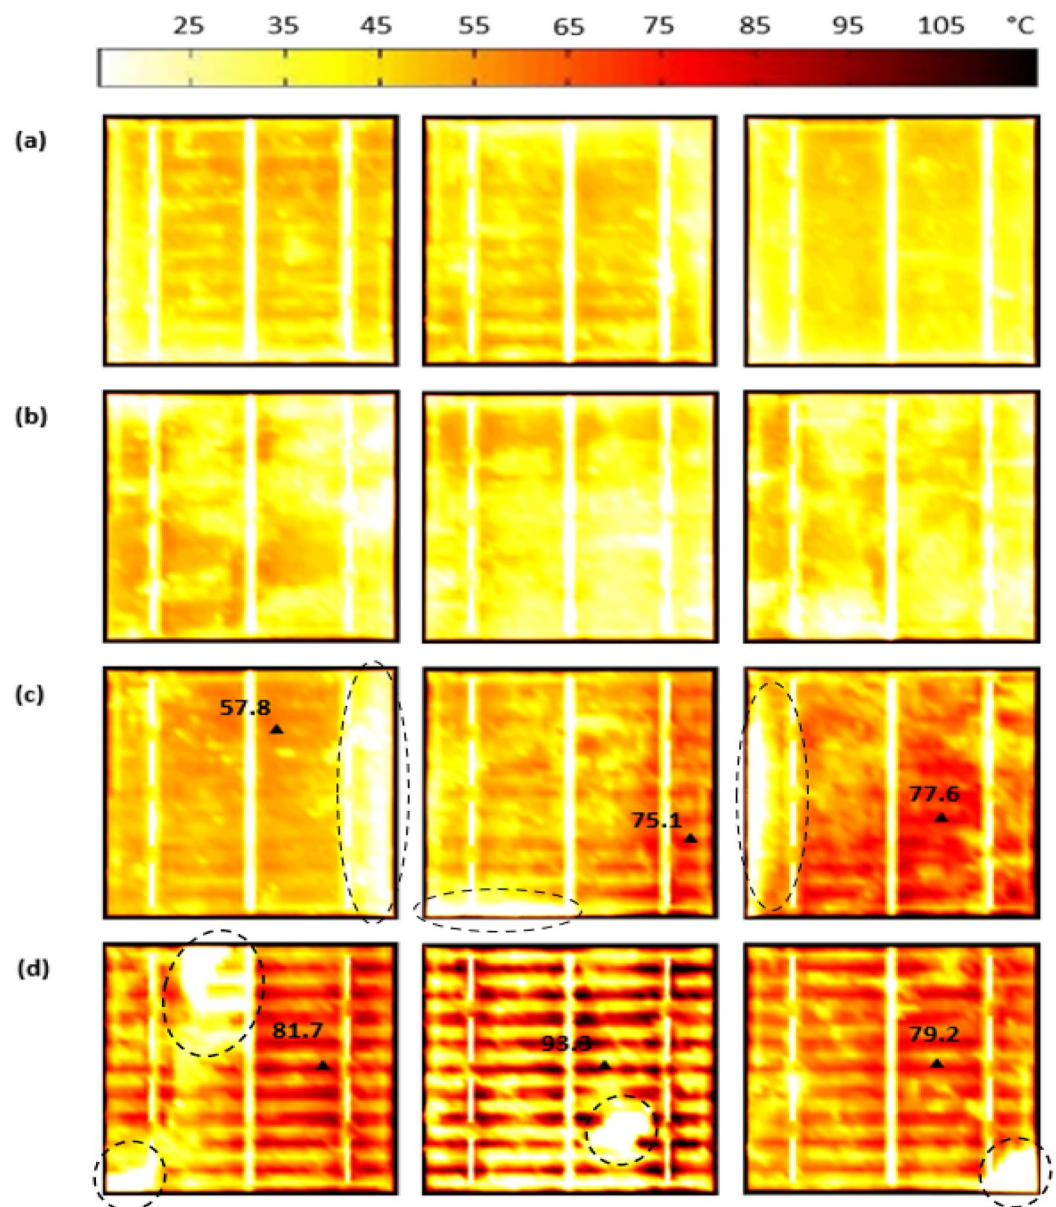
**Figure 5.** Thermal image of the examined solar cell samples under STC condition (a) mode 1, (b) mode 2, (c) mode 3, and (d) mode 4.

**Thermal performance of the tested solar cell samples.** The results of the thermal testing are shown in Fig. 5. According to Figs. 5a,b a uniform distribution of the heat across the solar cell surface was detected. Accordingly, the temperature is approximately at the standard testing condition, 25°C. It is noticed that no hot-spots are exposed to the solar cell samples with crack-free (mode 1) and micro-cracks (mode 2). Furthermore, for crack modes 1 and 2, there was no increase in the cell's temperature, which confirms that crack-free or micro-cracks do not change the temperature of the cells and are unlikely to develop a hotspot.

In contradiction, if we consider Fig. 5c, mode 3, the shade in the cells causes no increase in the temperature, labelled in dashed circles. The shade will create an uneven distribution of the current flow in the busbars; this would generate stress in the cell and then cause an increase in the temperature. We can observe that the samples are affected by the rise to the surface temperature up to 77.6°C. Hence, if these samples were under field operation, hotspots would be expected. We yet do not fully understand the correlation between the shading ratio in the original EL image and the presence of hotspots; this case will be detailed later in the article.

According to mode 4, Fig. 5d, the breakdown regions in the solar cells have no increase in the temperature, labelled in dashed circles. This is explained by the fact that there is no contact in the inner and outer layers of the cells. Hence, no photo illumination is observed. In contrast, the cells are now being impacted by an increase in the surface temperature (of up to  $93.3^{\circ}\text{C}$ ) due to these breakdown regions. The same explanation is valid as in crack mode 3, where breakdown regions affect parts of the solar cells, which would create an uneven distribution of the current flow in the busbars, leading to this significant increase in the cell surface temperature. A similar observation was made in the recent study by Akram *et al.*<sup>27</sup>, where they discovered that a hotspot could lead to an increase in the cell surface temperature of up to  $110^{\circ}\text{C}$ .

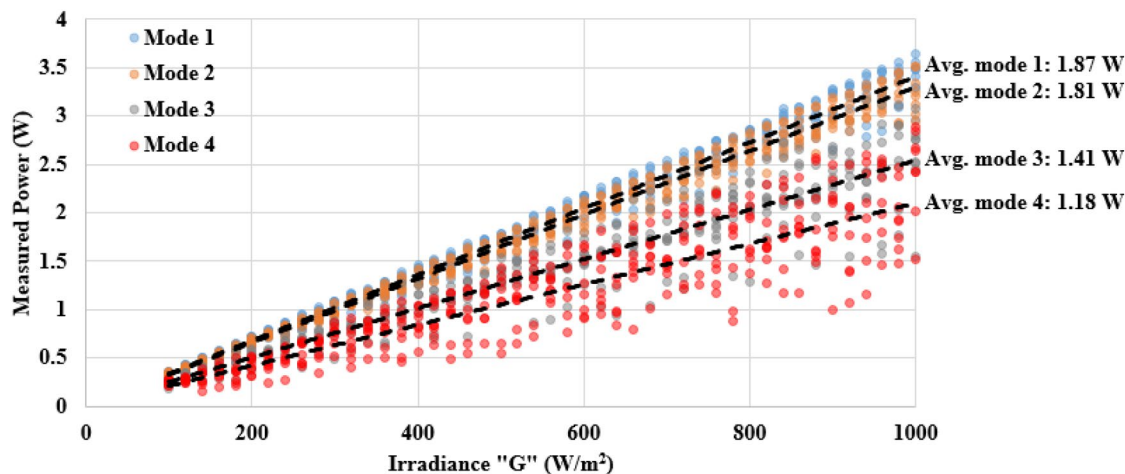
**Figure 6.** Measured power vs irradiance of the examined solar cells.

**Output power measurements.** Using the solar simulator, the examined samples were subjected to illumination over the spectrum range from 100 to  $1000\text{ W/m}^2$ . The results of each mode are given in Fig. 6, including the linear regression. Modes 1 and 2 have a similar output power pattern, and their average measured power is 1.87 W and 1.81 W, respectively. On the other hand, a significant drop in the measured power for modes 3 and 4 is observed, averaged at 1.41 W and 1.18 W, respectively.

We show here that for modes 1 and 2, there is an insignificant change for the maximum-to-minimum output power across the range of the solar spectrum. However, for modes 3 and 4, a considerable difference in the measured power, particularly at high solar irradiance ( $> 500\text{ W/m}^2$ ).

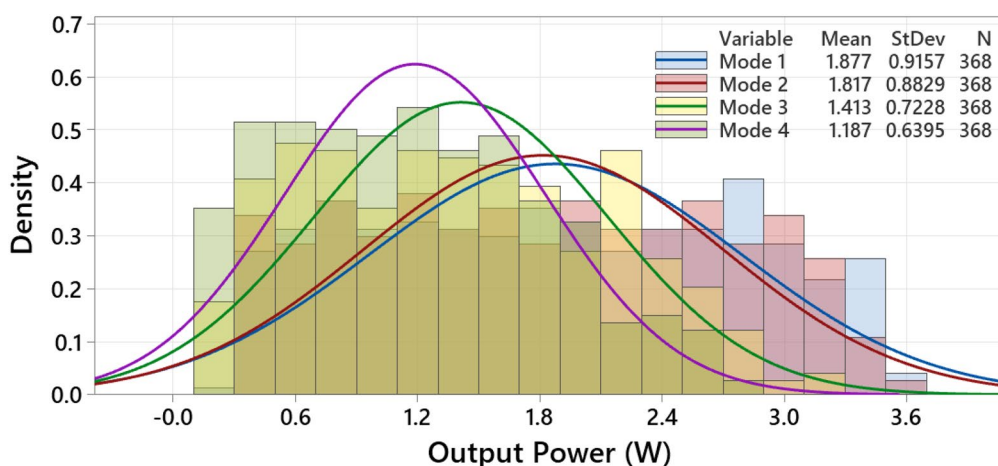
**Figure 7.** Normal distribution function applied for all measured data points.

Additionally, we summarise that the measured output power of the solar cell samples follows a normal distribution as presented in Fig. 7. However, a lower standard deviation (StDev) for modes 3 and 4 indicates that the output measure power tends to be close to the mean value. This result suggests that a significant drop in the

solar cells' output power is likely to be noticed if the EL image exhibits a shaded area or breakdown regions. Finally, please note that for Fig. 7, the y-axis (density) represents the percentage of the observations in the dataset.

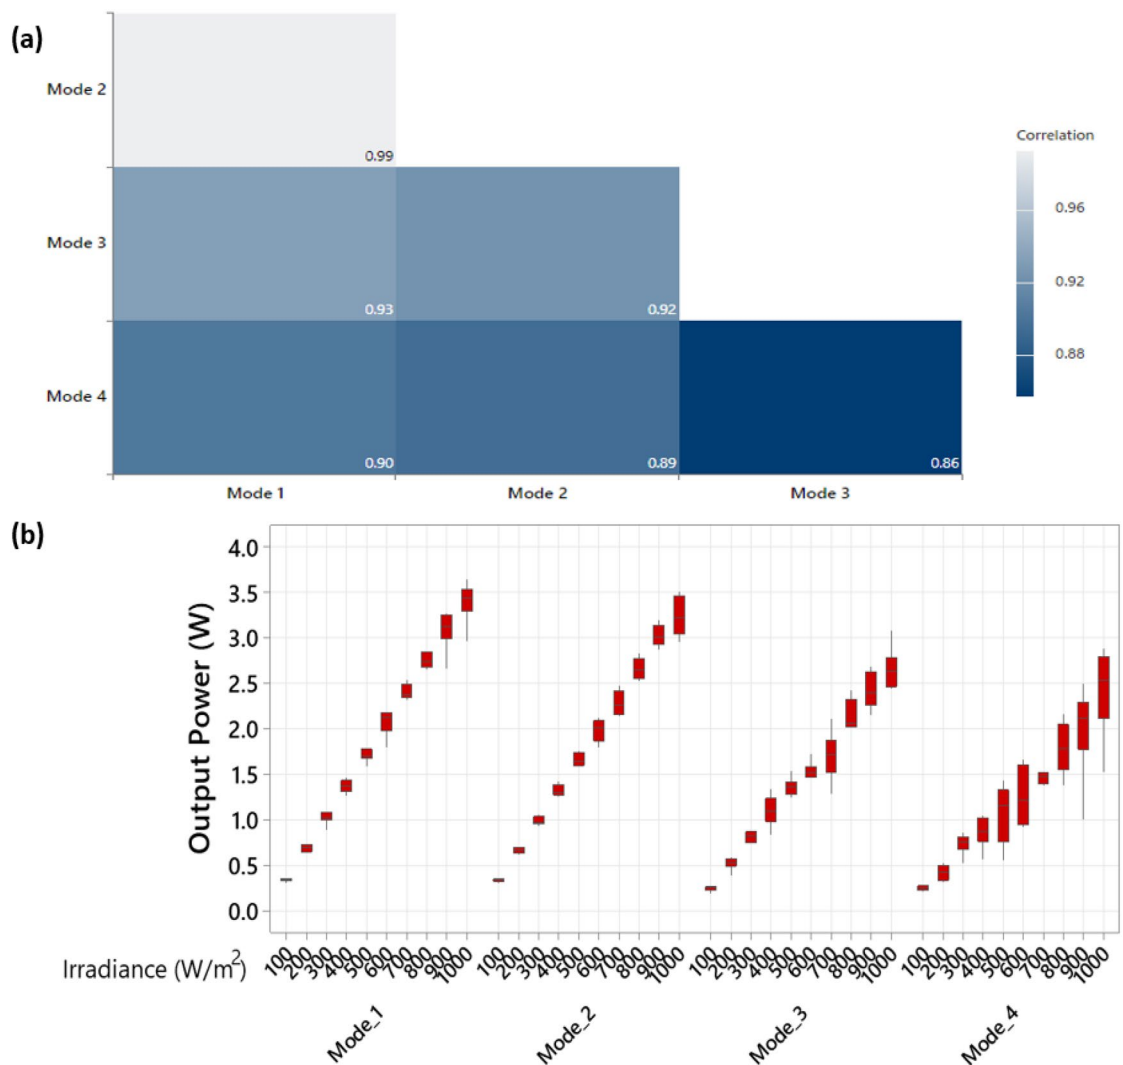
**Figure 8.** (a) Correlogram graph for the different solar cell crack modes investigated in this work, and (b) Solar irradiance vs output power of each crack mode.

Taking the measurements of the output power of each solar cell cracks mode, the correlogram is compiled and presented in Fig. 8a. In this figure, we notice that even though modes 3 and 4 looks similar in the original captured EL images, both have the least correlation, 0.86 or 86%. This outcome is found due to the nature of the cells' breakdown regions (mode 4). Therefore, they are likely to exhibit an unpredictable power loss and increase the cell's temperature with multiple levels, as small as  $50^\circ\text{C}$  to  $93.3^\circ\text{C}$ . On the contrary, the solar cells affected by crack mode 3 are likely to have a drop in the output power with steady fluctuations, as analysed in Fig. 8b, compared with mode 4.

Finally, and as expected, the highest correlation is marked for modes 1 and 2 at 99%. Because both crack modes exhibit the same output power losses, and they show no impact on the cell's temperature.

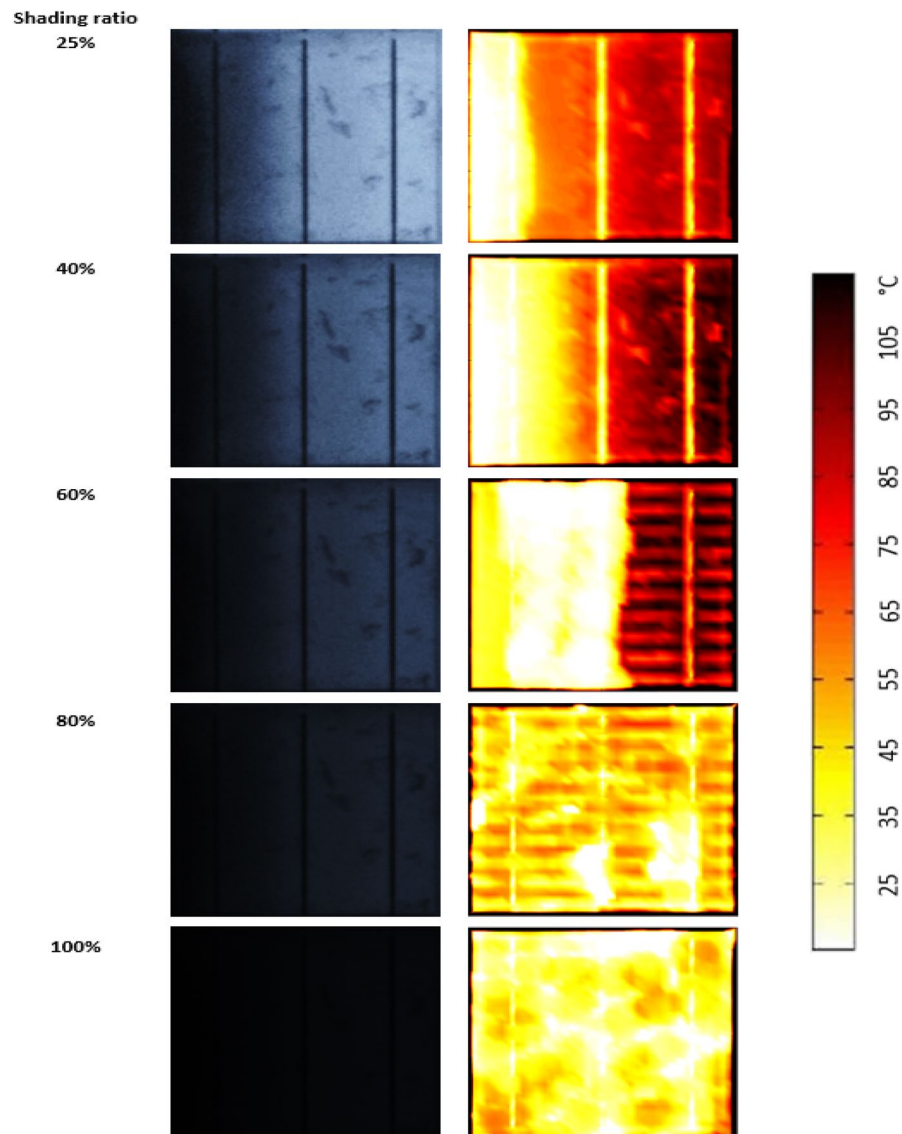
**Figure 9.** Progressive shading of a solar cell affected by mode 3 crack; the samples were subjected to illumination under STC conditions.

**Shading ratio vs hotspots development.** So far, we have evidence that solar cells affected by modes 3 and 4 are expected to have hotspots. Therefore, we have further investigated the correlation between the shade ratio in mode 3 and the presence of hotspots. The outcome of this experiment is presented in Fig. 9.

The progressive range of shade, including 25%, 40%, 60%, 80%, and 100%, is examined. If the solar cell is affected by 25% shading ratio, a maximum increase in the cell's temperature of approximately  $75^\circ\text{C}$  is detected. Progressively, if the solar cell is affected by a greater shading ratio, 40% or 60%, the hotspot area has a significant

increase in temperature, equivalent to 105°C. Therefore, a hotspot is likely to develop for these three shading ratios.

For the last two shading ratios, when the solar cell is affected by 80% or 100%, no hotspot in the cell area is witnessed. The hotspot disappears due to the absence of the photo-generated current. The remaining dark current flows within the cell for insignificant cell heating and an average temperature approximately at the experimental condition, 25°C. Thus, the worst-case scenario for the hotspot to develop occurs at the shading ratios of 40% to 60%, with an expected increase in the cell temperature from 25°C to 105°C.

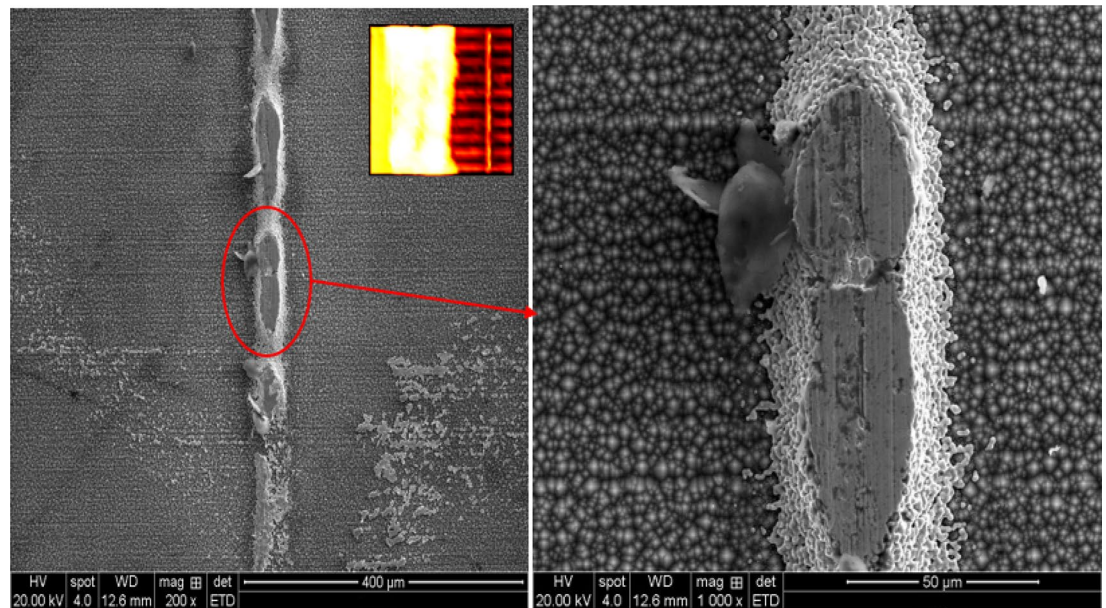
**Figure 10.** Capturing the busbar under SEM of the solar cell affected by 60% shading ratio.

Therefore, we have scanned the solar cell affected by a 60% shading ratio under SEM. This experiment was performed after the cell has been under illumination (1000 W/m<sup>2</sup>) for three continuous hours. The SME image of the hotspot busbar is presented in Fig. 10 under 200 and 1000 magnification. Here we can observe that the hotspot develops stress in the busbar and the surrounding area in the form of cracks. In theory, busbars are made of copper-plated silver, and silver plating is necessary to improve current conductivity.

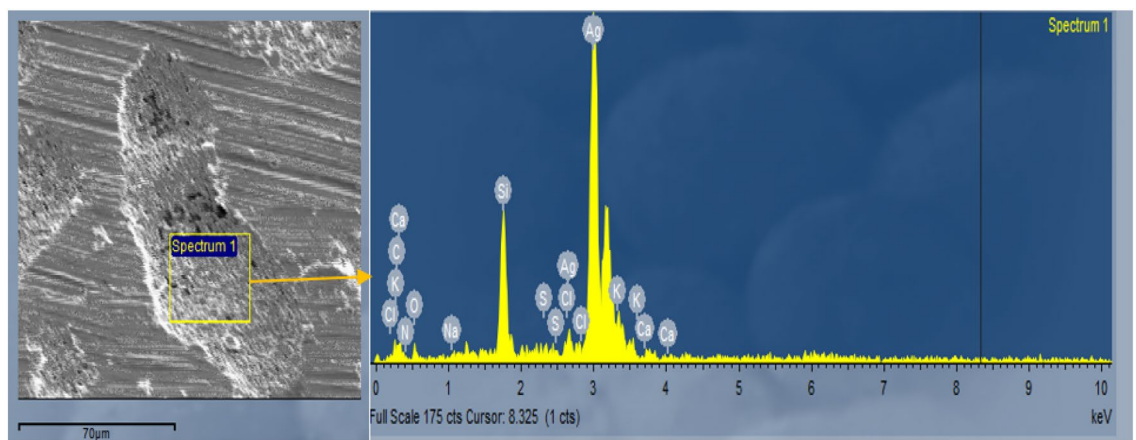
**Figure 11.** The busbar has 60% silver, 37% silicon, and 2% other material.

In this experiment, the material of the affected region of the busbar was obtained using the SEM image. According to the results shown in Fig. 11, it is recognised that the material (silicon) of the defective area of the cell is merged with silver, significantly reducing the busbar silver-plate composition, 60% silver, 37% silicon, and 2% other material. This arrangement in the solar cell is merely evidence of why the current is dropping in the non-shaded area of the cell, making this part of the cell affected by a significant increase in the temperature (hotspot).

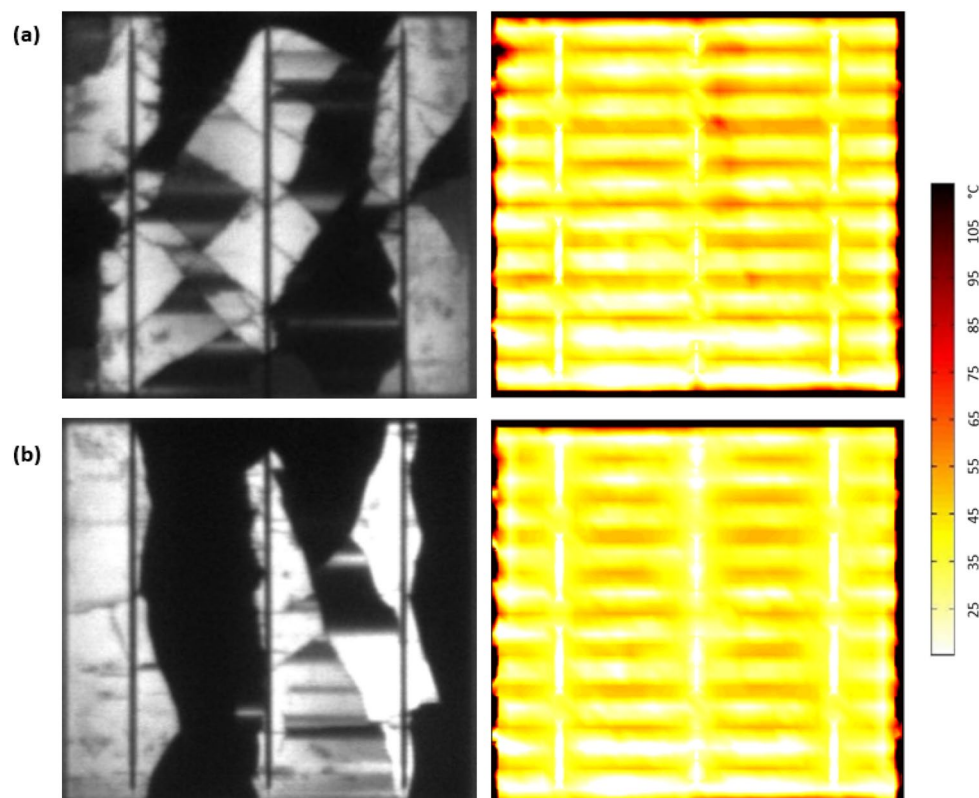
**Figure 12.** Solar cells affected by mode 4 with severe breakdown regions (a) sample #1, and (b) sample #2.

Finally, two solar cells (Fig. 12) were tested for further validation of the above-mentioned results. Both samples are affected by mode 4, with severe breakdown regions. The inactive part is approximately higher than 70%, represented by the dark black areas in the EL image. Both samples were tested under STC conditions using the

solar illuminator. Because the inactive region is very high, no increase in the cell's temperature was detected. This result confirms that when the solar cell is impacted by a high ratio of shading or breakdown regions, the hotspots are unlikely to develop.
